U. S CIVIL AERONAUTICS BOARD

AIRCRAFT ACCIDENT REPORT

UNITED AIR LINES, INC , DC-8, N 8013U, AND
 TRANS WORLD AIRLINES, INC., CONSTELLATION 1049A, N 6907C,
 NEAR STATEN ISLAND, NEW YORK, DECEMBER 16, 1960

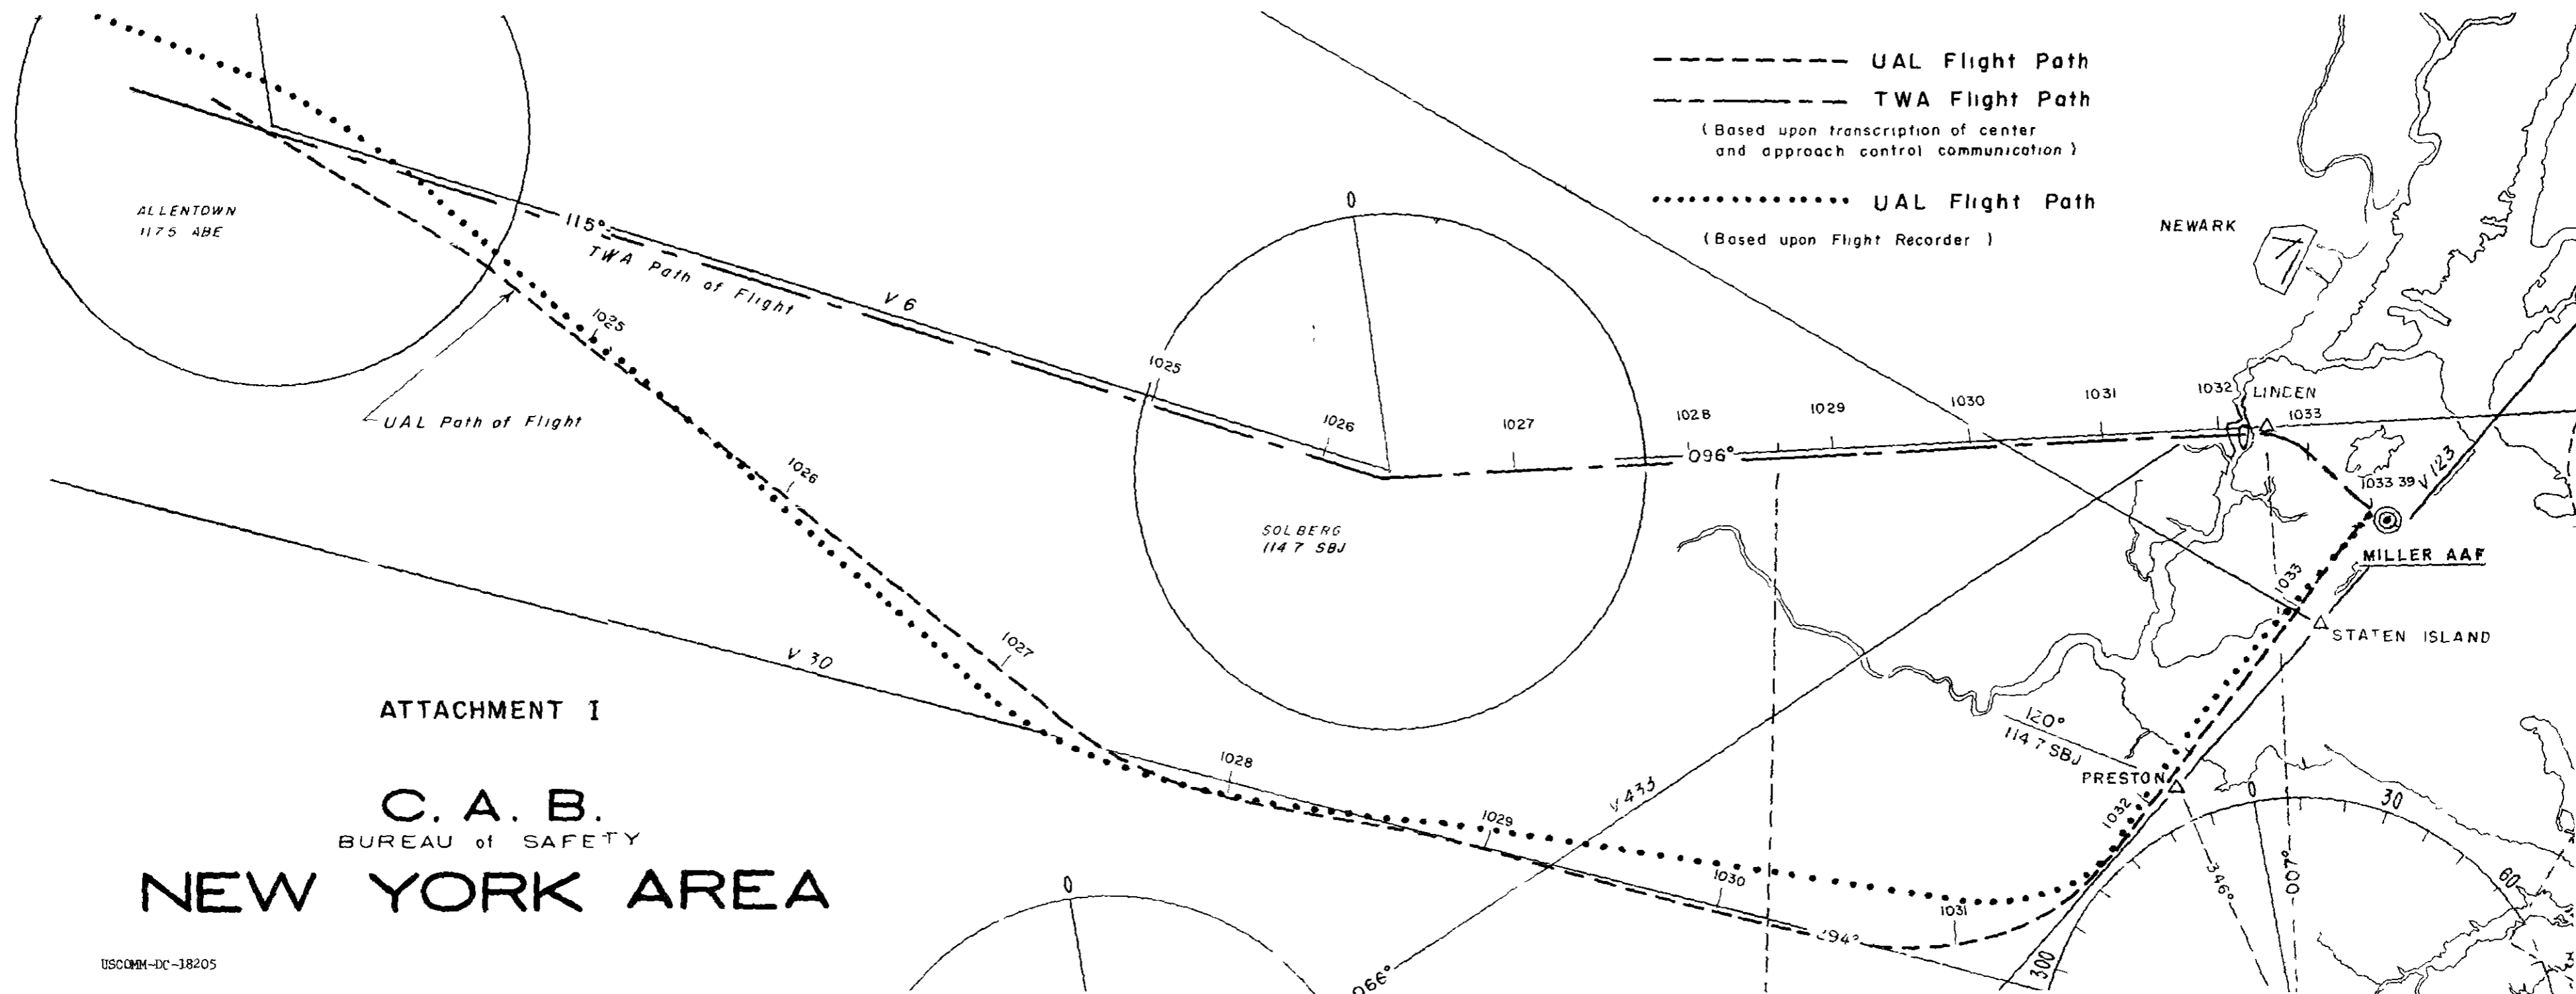
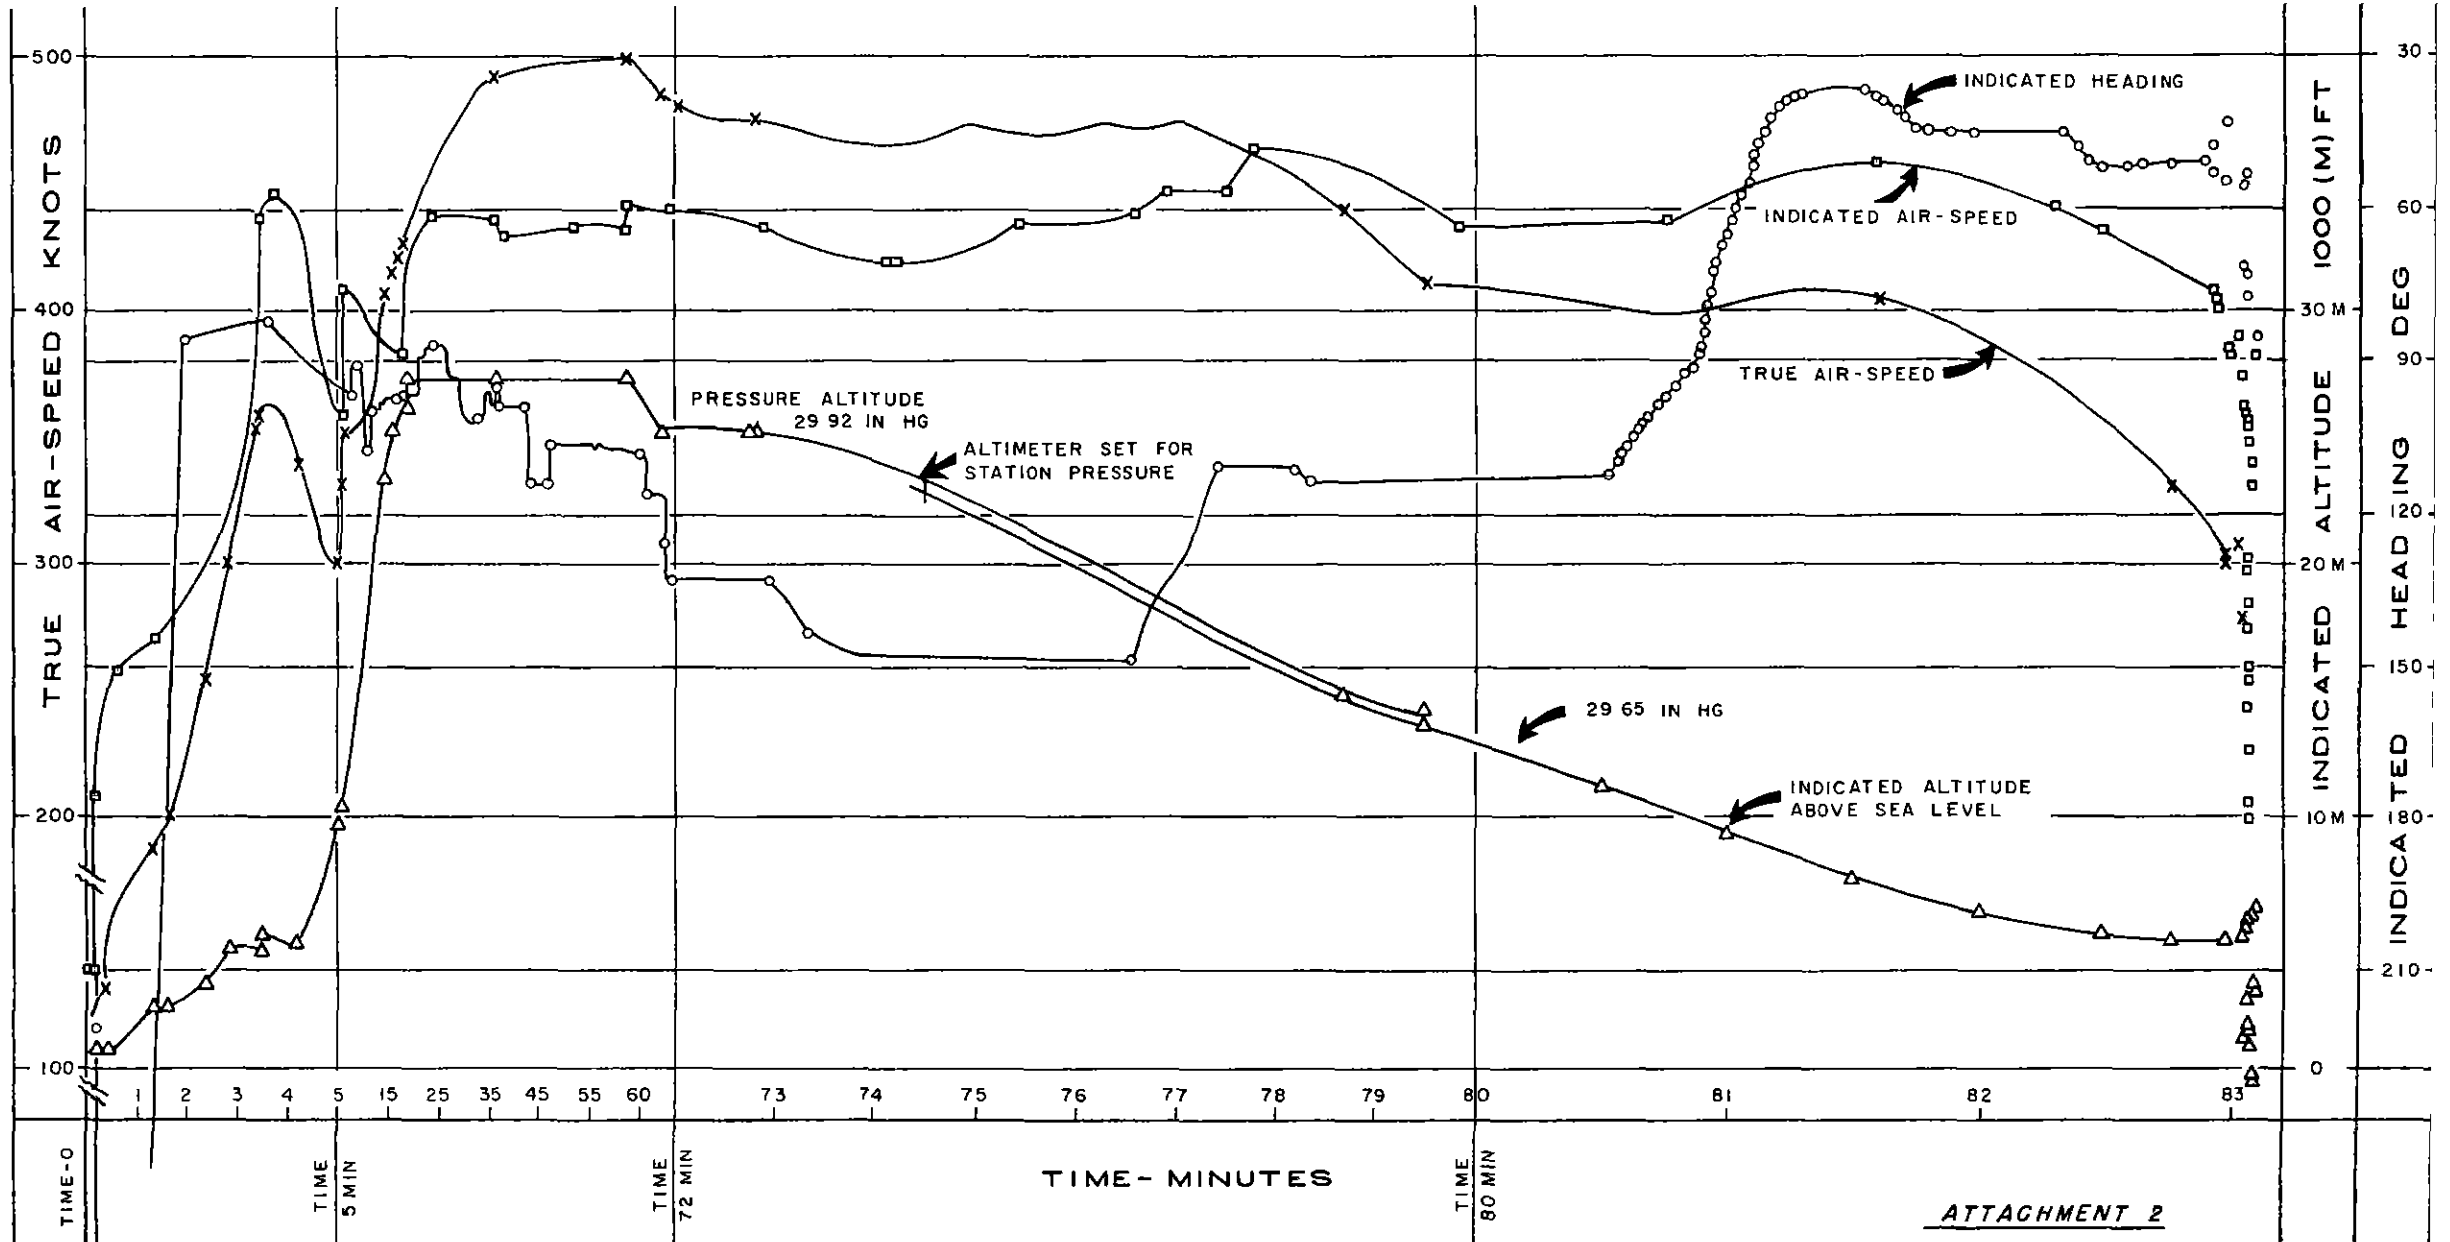
ATTACHMENT I

History of TWA Flight (See Attachment I as reference)
